SPECIAL AIRWORTHINESS INFORMATION BULLETIN

No. NE-03-50
August 21, 2003

Number CW03-01

Subject: Capewell Supplied Pins and Ripcords

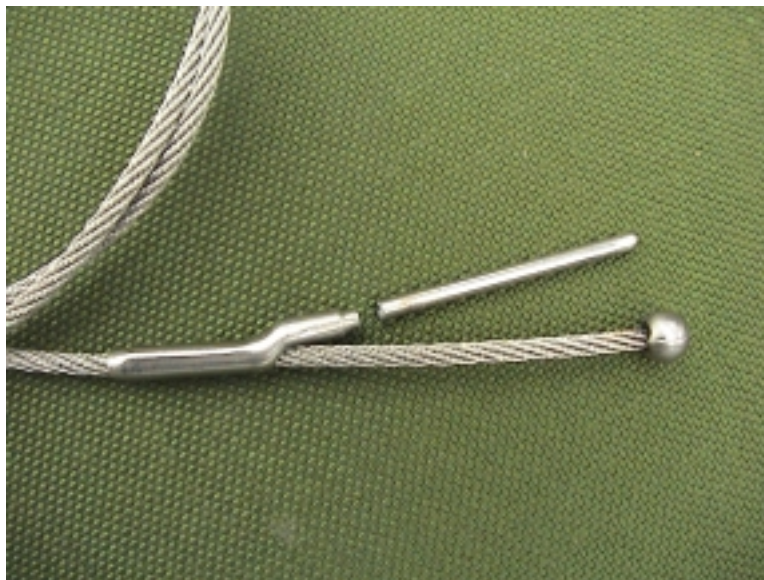
Broken Ripcord Pin

Capewell Components LLC has received (3) reports from (3) customers of (4) ripcord pins that broke. All (4) pins were reported to have broken under very low force. All (4) pins are reported to have broken on the blade section of the pin, approximately 1/8" (3 mm) from the shoulder of the pin. A broken pin is pictured below.

Capewell has an on-going investigation to determine root cause. No root cause(s) has been determined to date.

Due to the potential consequences of a failed pin, the FAA strongly recommends all parachute users inspect their ripcord pins in accordance with the Capewell Service Bulletin. The suspect pins were delivered during the period from November 28, 2001 through July 15, 2003. Since there are no markings on the pins, we strongly recommend all parachute riggers and owners, inspect all ripcord pins unless you are sure the pins were manufactured outside the above delivery period.

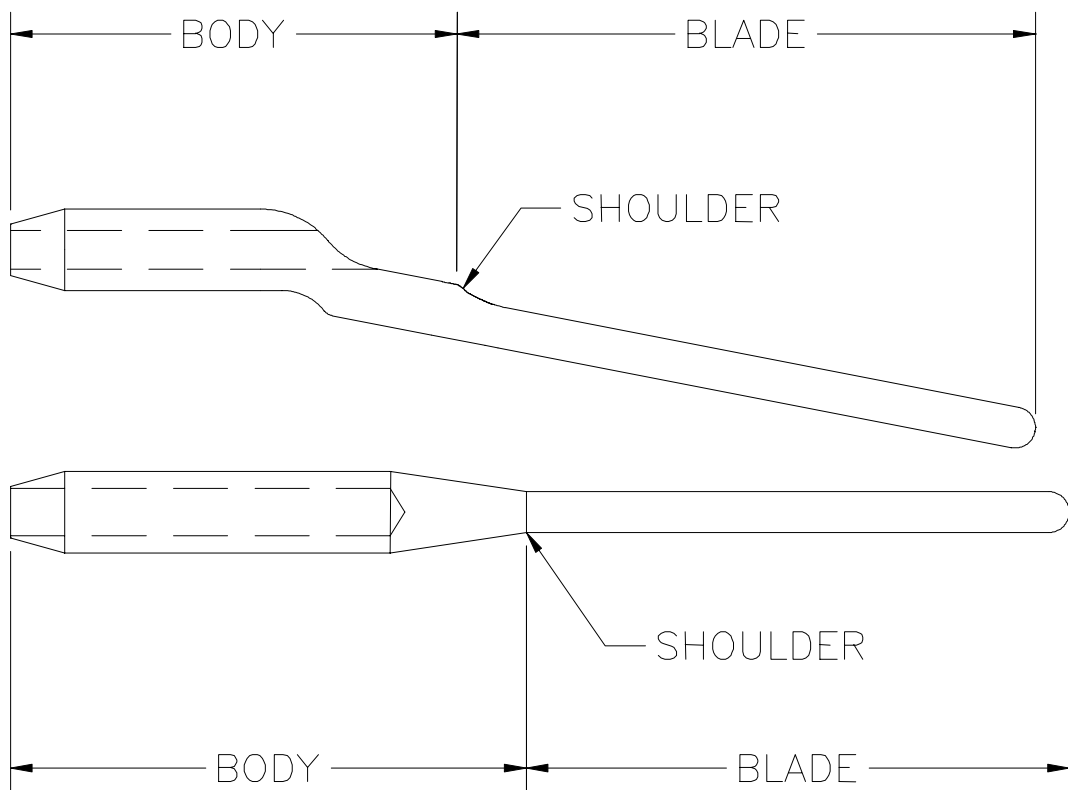
The figure below is provided for clarity to all procedural instructions.

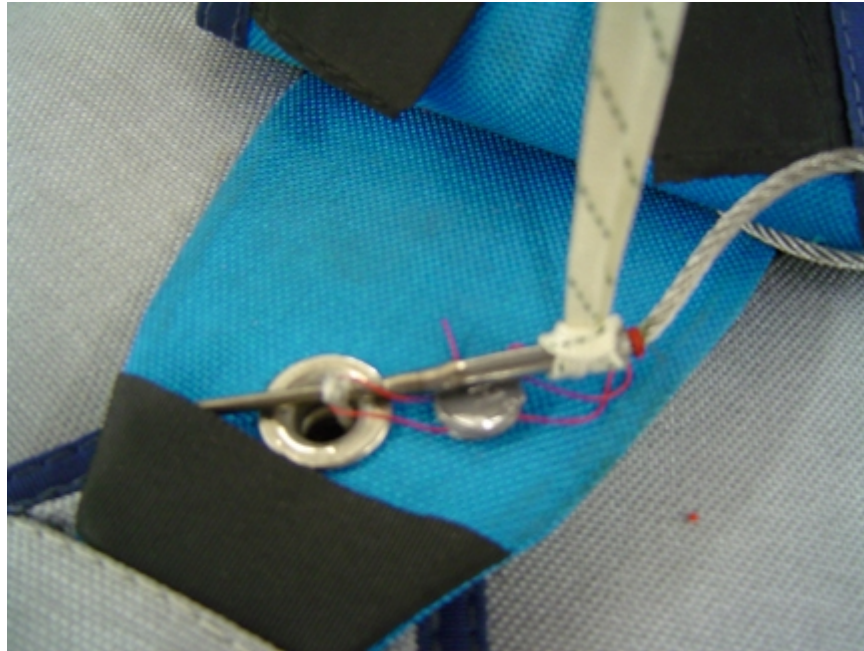
FIGURE 1

3. Take the suspension line and tie the two ends together with an overhand knot forming a loop.
4. Route the loop around the body of the pin to form a lark's head knot as close to the cable entrance end of the pin body as possible (Fig. 1).

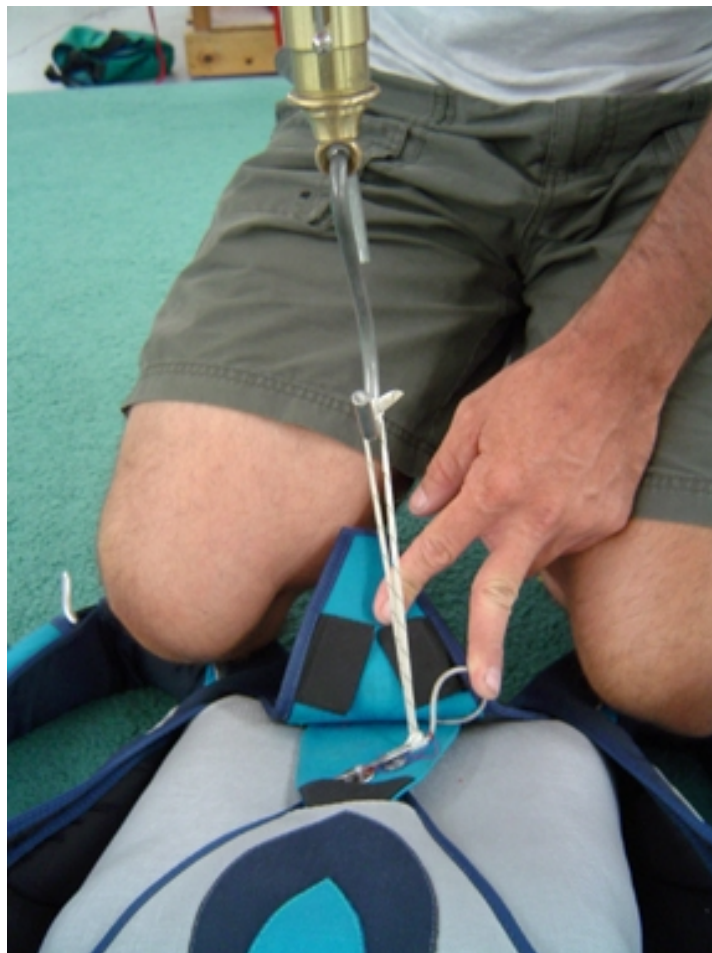
FIGURE 2

5. Secure the other end of the loop to the spring scale.
6. Apply a load of 15 lbs. (6.8kg) straight up and 90 degrees to the axis of the pin for a period of 3 seconds and then release the load (Fig. 2). Inspect the pin for any deformation or bend. If the pin is straight, continue with step 7 below. If the pin is not straight, as visible without magnification, remove the pin/ripcord from service immediately.

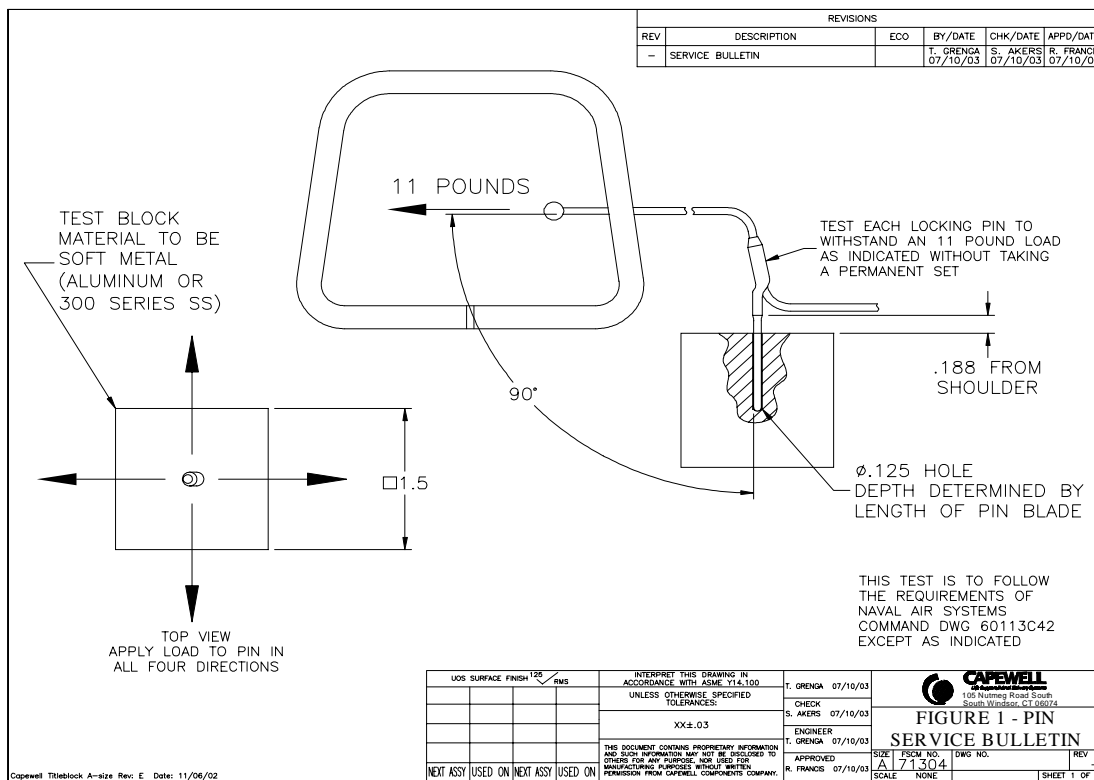
FIGURE 3
All dimension in inches

1. Place pin in test block per Figure 3 (below). NOTE: The pin block hole may be VERTICAL or HORIZONTAL
2. Apply 11 lb. force 90 degrees perpendicular to the pin blade.

3. Remove pin from block and inspect:
 - For straightness: Pins in excess of .005 (.12 mm) deformation along the blade of the pin should be removed from service.
